**Re:** Enviro-Chem Superfund Site

**Monthly Construction Progress Report Number 9**

August 1998

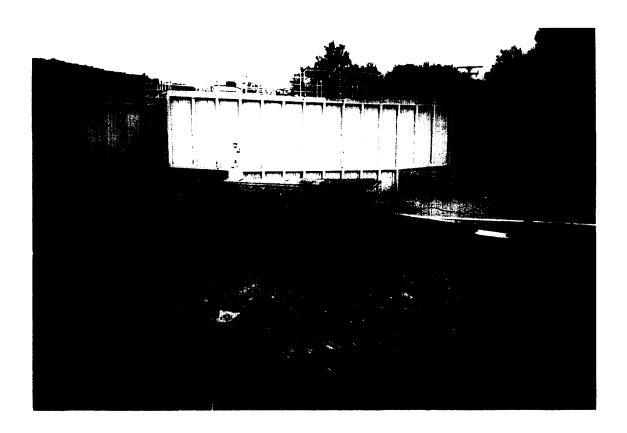
Photograph # 1: Show a stack of sheet pile recently removed from the east wall of SCP Area.
